NASA/TP-97-206257

The Characteristics of Fatigue Damage in the Fuselage Riveted Lap Splice Joint

Robert S. Piascik
Langley Research Center, Hampton, Virginia

November 1997

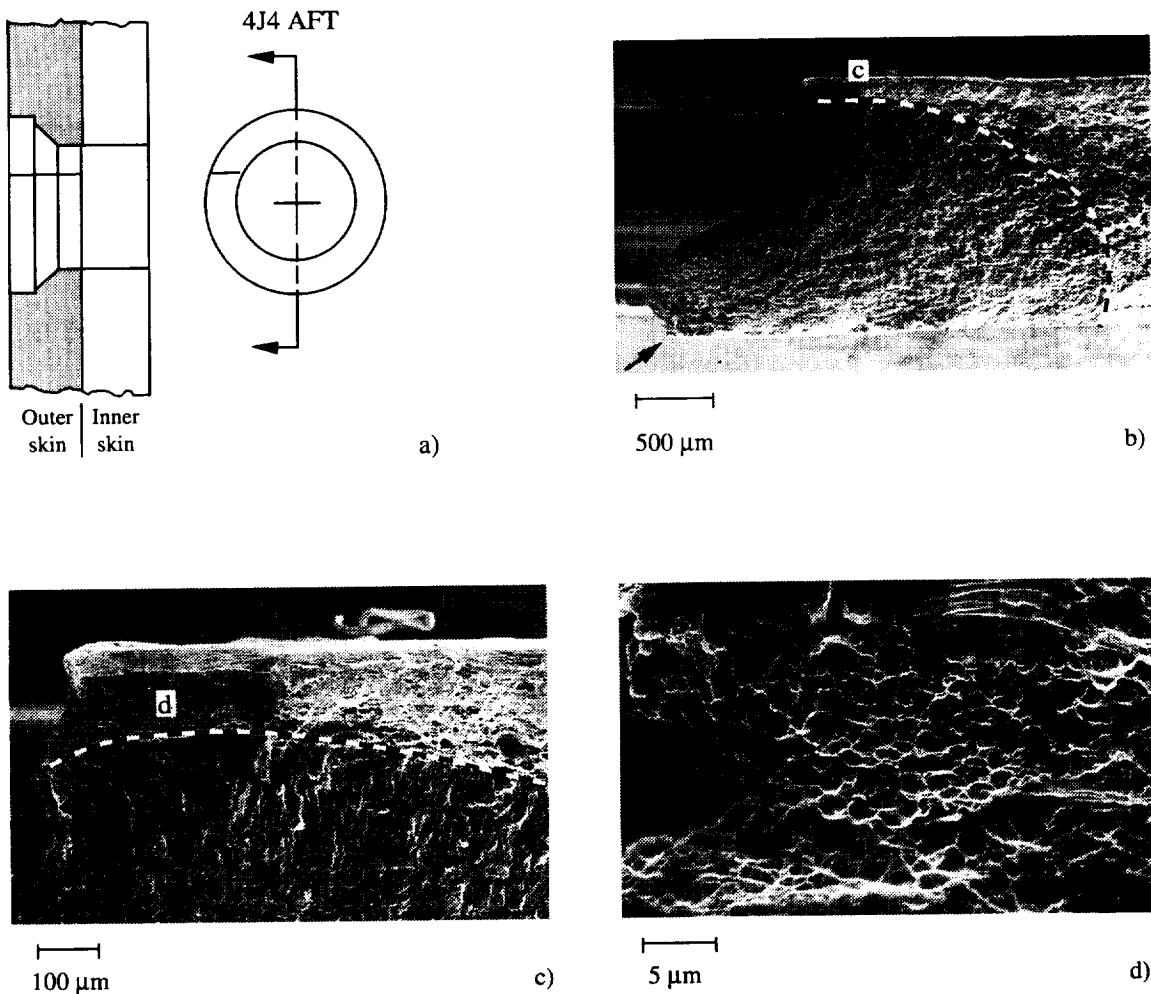
Figure 11.15 a) The schematic shows the rivet hole 4J4 configuration and the location of the outer skin fatigue crack oriented in the aft direction and about the 10 o'clock position. b) The SEM micrograph shows the fatigue crack fracture surface located at the outer skin rivet hole (left). The arrow marks the likely region of crack initiation and the dashed line marks the fatigue crack front. c) The SEM micrograph shows the fatigue crack front and the ligament, region "c" in Figure 11.15.b. The dashed line marks the fatigue crack front where it intersects the rivet hole (left). The outboard surface of the outer skin is located at the top of the micrograph. d) The SEM micrograph shows the ductile morphology of the overload fracture surface at region "d" in Figure 11.15.b at high magnification.

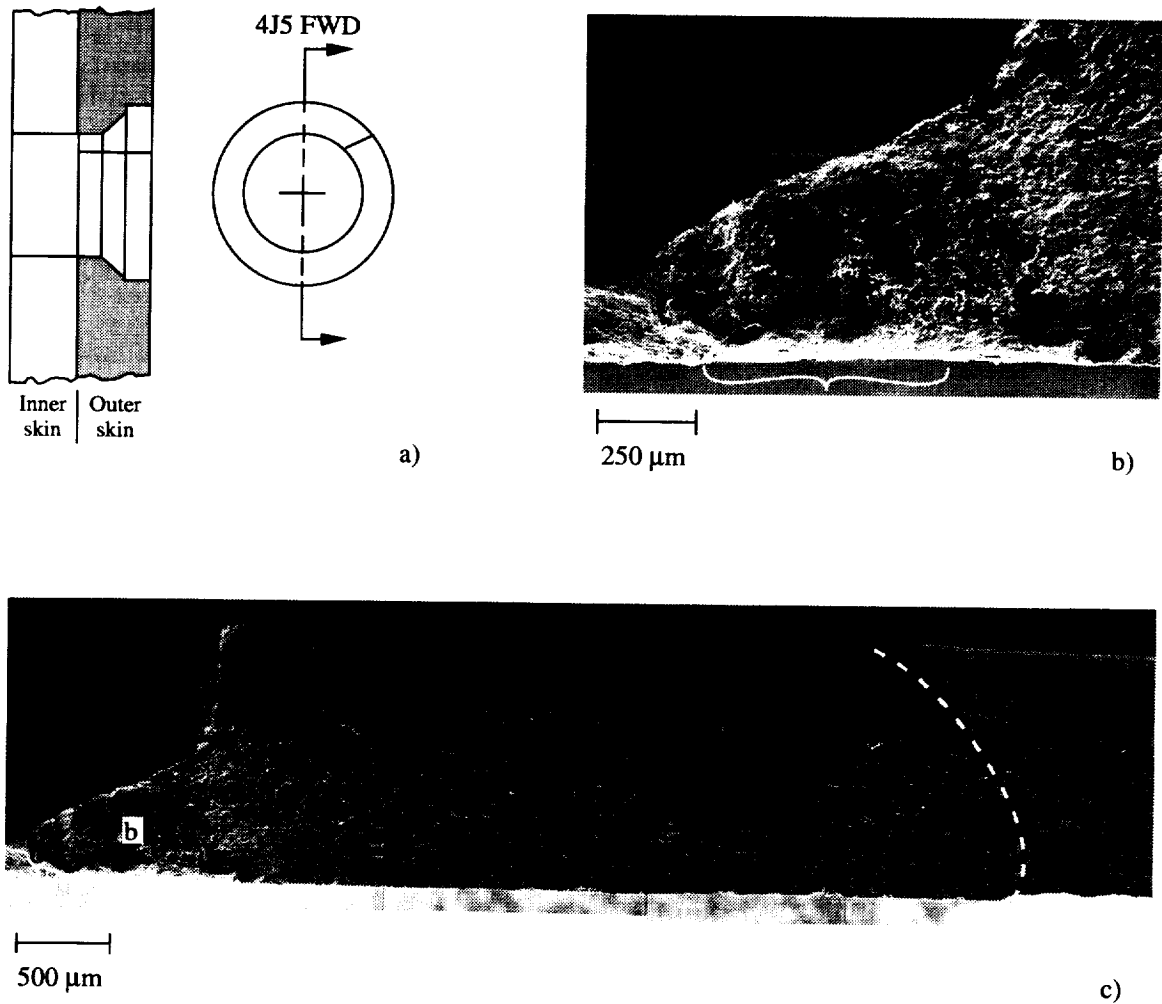
Figure 11.16 a) The schematic shows the rivet hole 4J5 configuration and the location of the outer skin fatigue crack oriented in the forward direction and about the 2 o'clock position. b) The SEM micrograph shows the fatigue crack fracture surface located at the shank, region "b" in Figure 11.16.c. The bracket marks the likely region of crack initiation. c) The SEM micrograph shows the fatigue crack fracture surface located at the outer skin rivet hole (left). The dashed line marks the fatigue crack front.

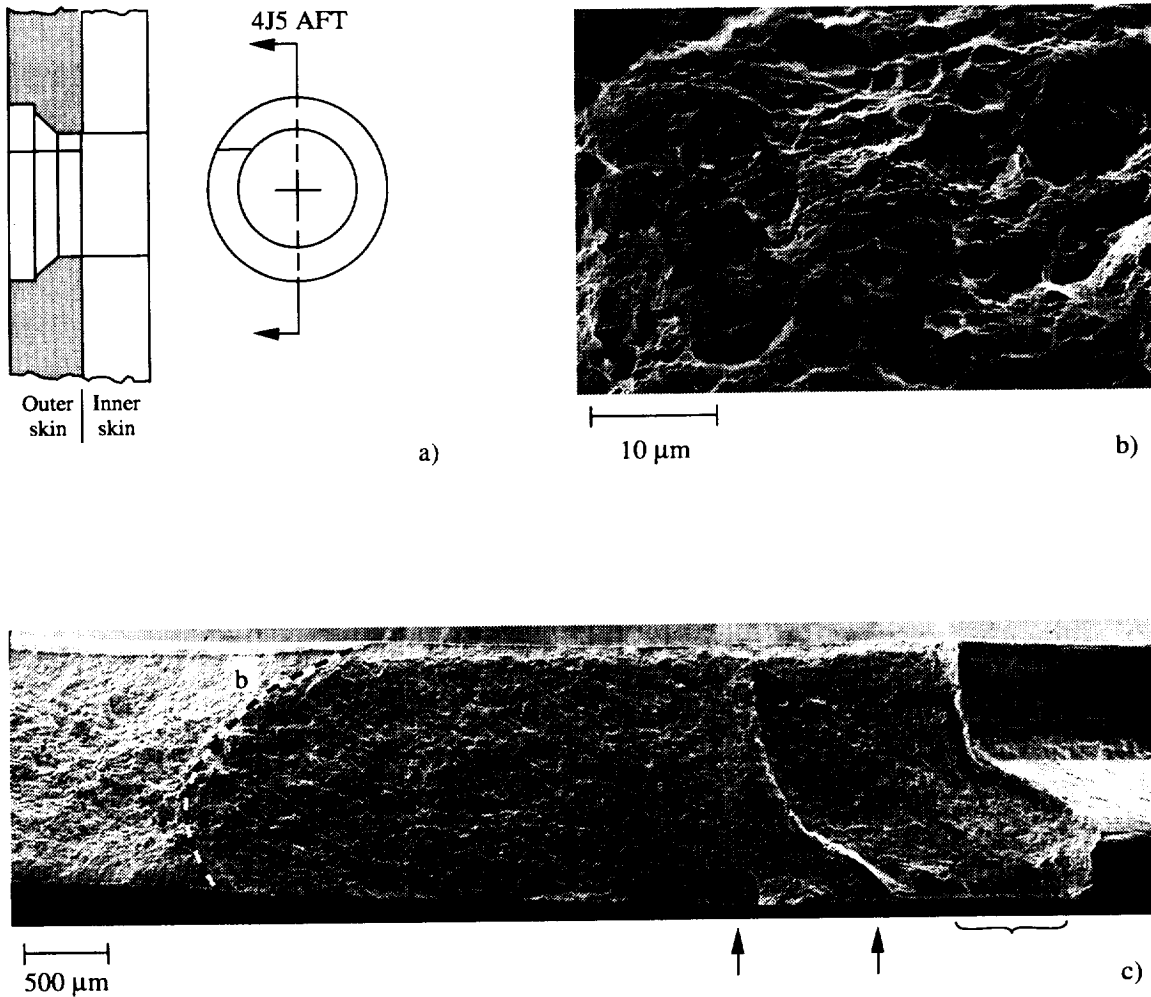
Figure 11.17 a) The schematic shows the rivet hole 4J5 configuration and the location of the outer skin fatigue crack oriented in the aft direction and about the 10 o'clock position. b) The SEM micrograph shows the ductile tearing morphology of the overload fracture surface at region "b" in Figure 11.17.c at high magnification. c) The SEM micrograph shows the fatigue crack fracture surface located at the outer skin rivet hole (right). The bracket and arrows mark the likely regions of crack initiation and the dashed line marks the fatigue crack front. Here, multiple fatigue fracture surface planes suggest that multiple fatigue cracks initiated along the faying surface and eventually coalesced into a single crack.

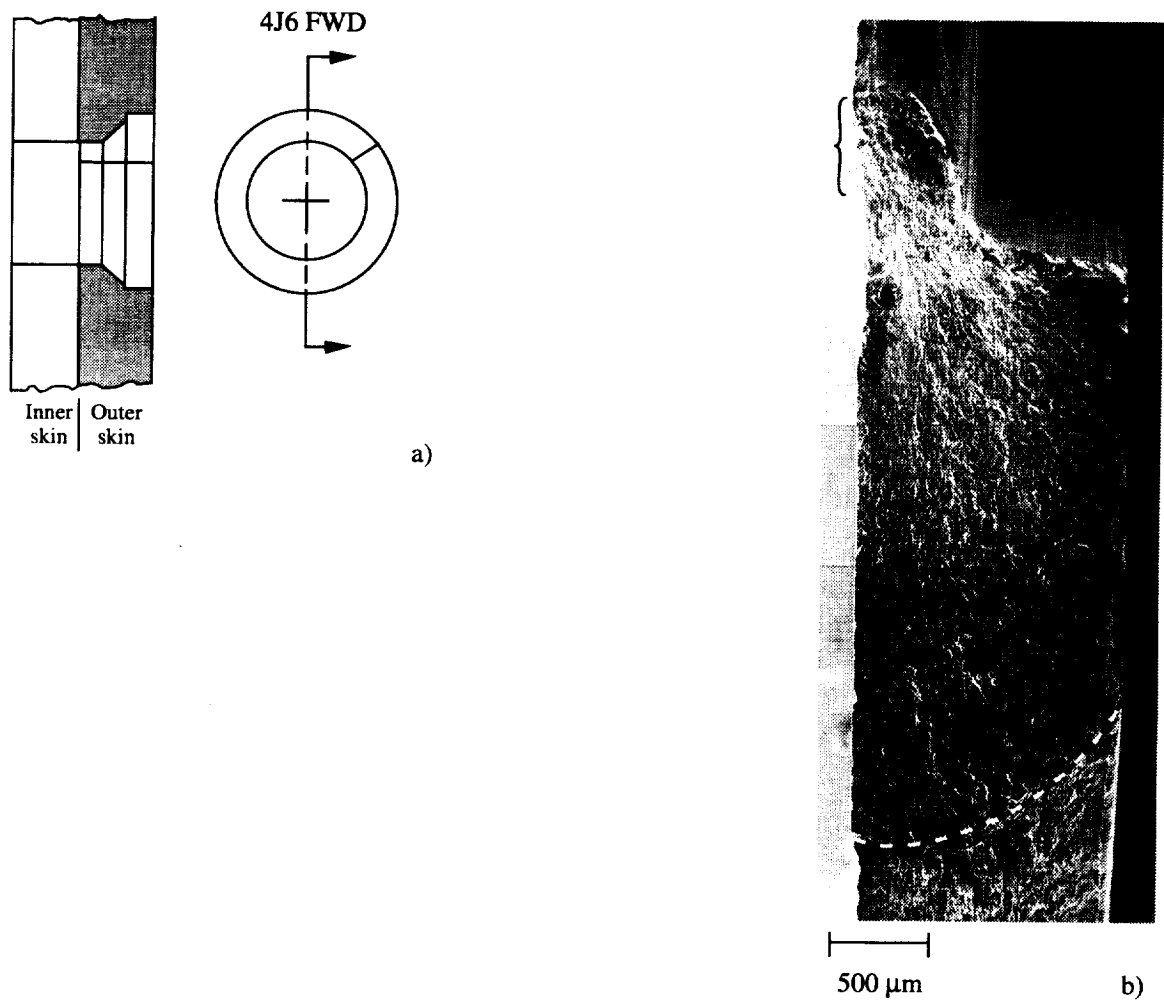
Figure 11.18 a) The schematic shows the rivet hole 4J6 configuration and the location of the outer skin fatigue crack oriented in the forward direction and about the 2 o'clock position. b) The SEM micrograph shows the fatigue crack fracture surface located at the outer skin rivet hole (top). The bracket marks the likely region of crack initiation and dashed line marks the fatigue crack front.

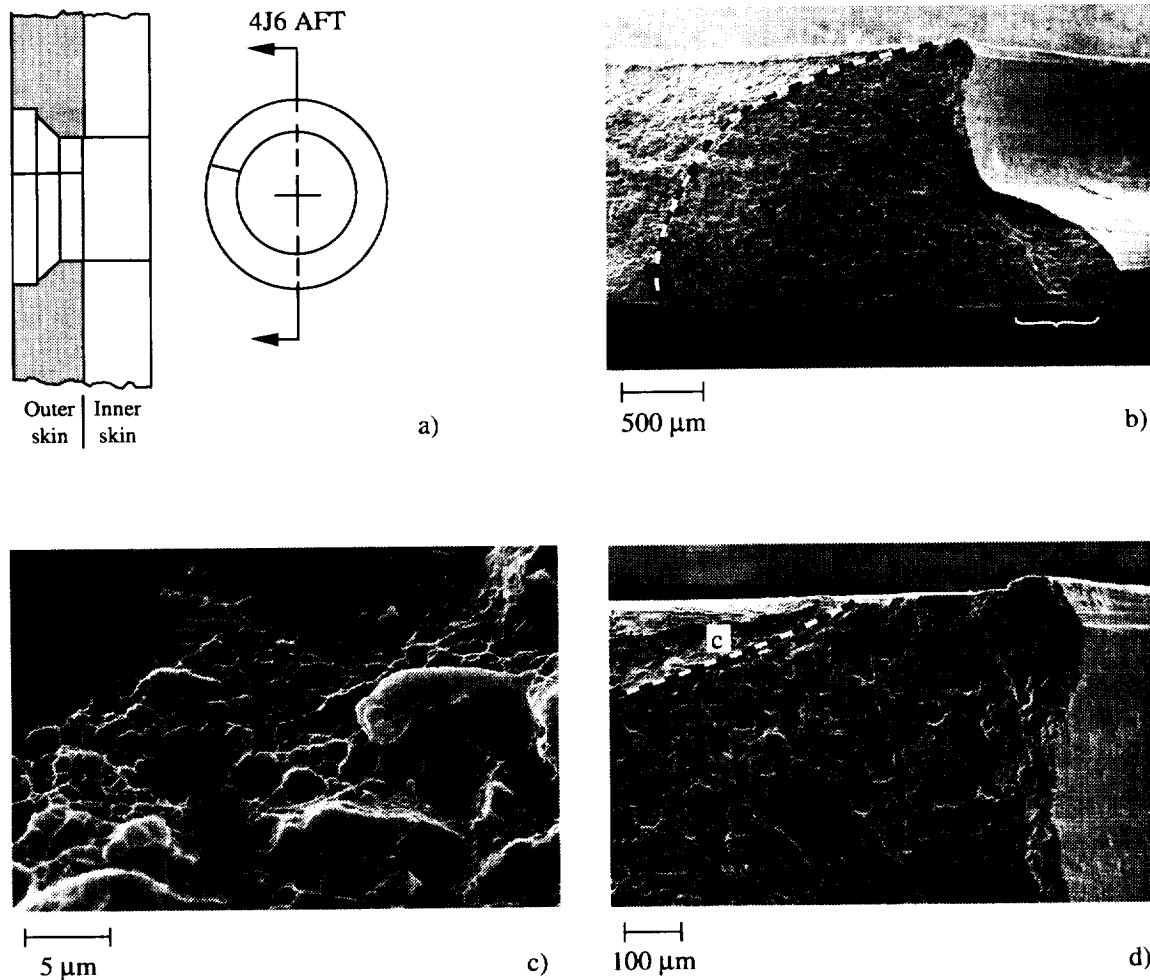
Figure 11.19 a) The schematic shows the rivet hole 4J6 configuration and the location of the outer skin fatigue crack oriented in the aft direction and about the 10 o'clock position. b) The SEM micrograph shows the fatigue crack fracture surface located at the outer skin rivet hole (right). The dashed line marks the fatigue crack front and the bracket marks the region of crack initiation. c) The SEM micrograph shows the ductile tearing morphology of the overload fracture surface at region "c" in Figure 11.11.d at high magnification. d) The SEM micrograph shows the fatigue crack front region (dashed line) as it intersects the outboard surface of the outer skin. The rivet hole is located to the right.

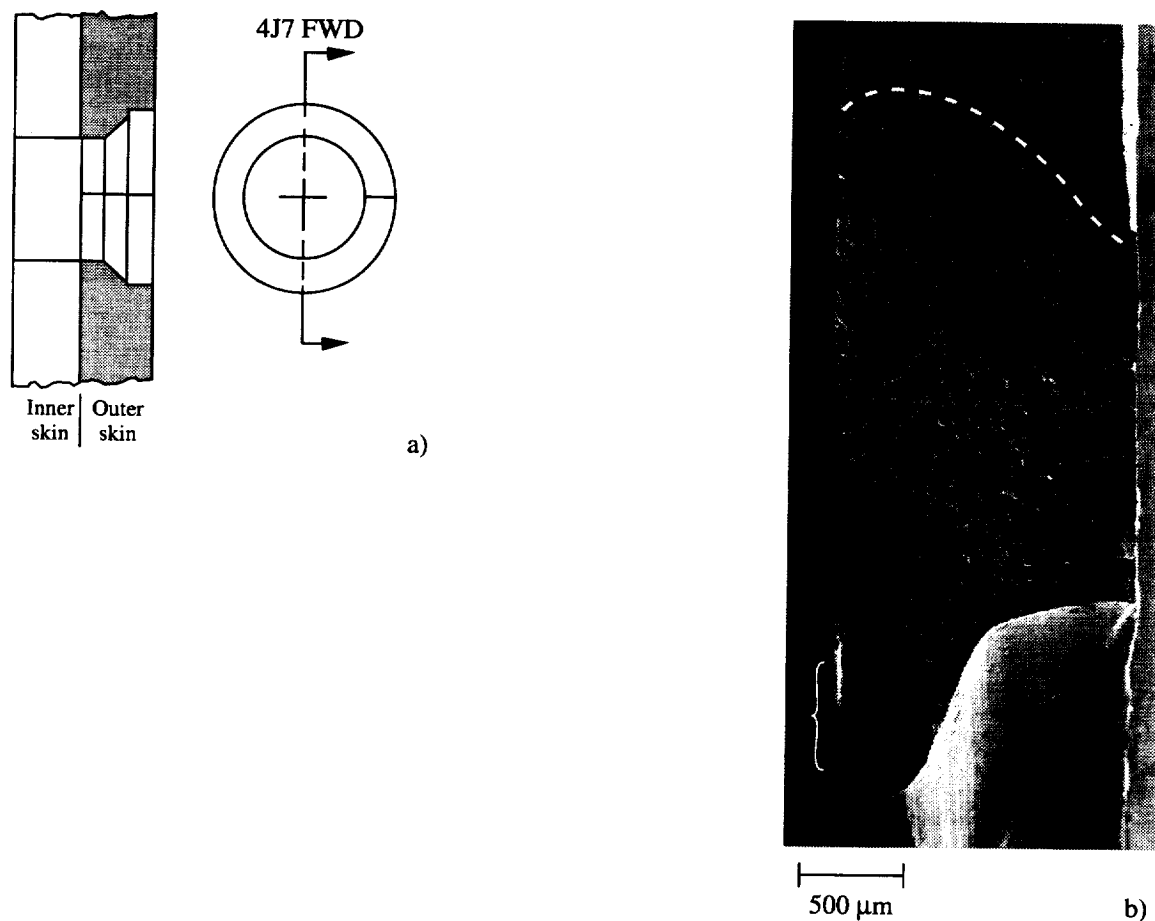
Figure 11.20 a) The schematic shows the rivet hole 4J7 configuration and the location of the outer skin fatigue crack oriented in the forward direction and about the 3 o'clock position. b) The SEM micrograph shows the fatigue crack fracture surface located at the outer skin rivet hole (bottom). The bracket marks the likely region of crack initiation and the dashed line marks the fatigue crack front.

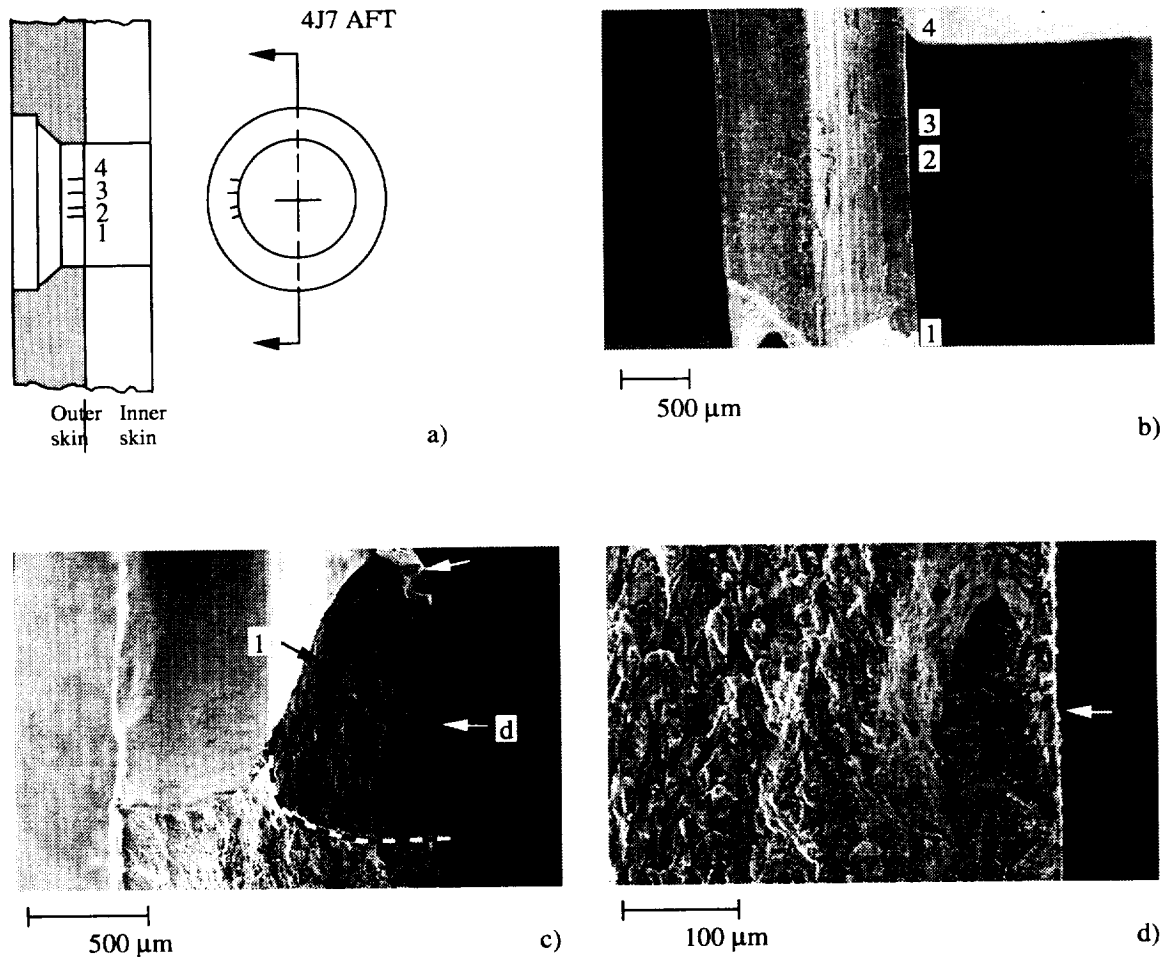
Figure 11.21 a) The schematic shows the rivet hole 4J7 configuration and the location of four outer skin fatigue cracks oriented in the aft direction and about the 9 o'clock position. b) The SEM micrograph shows the inner surface of the outer skin rivet hole and location of four fatigue cracks along the inboard region of the rivet hole. The main fracture surface is partially shown at the bottom of the micrograph. c) The SEM micrograph shows the main fatigue crack fracture surface (crack #1) at the rivet hole. The arrows mark the likely regions of crack initiation and the dashed line marks the fatigue crack front. d) The SEM micrograph shows the fatigue crack initiation site at region "d" in Figure 11.21.c at high magnification.

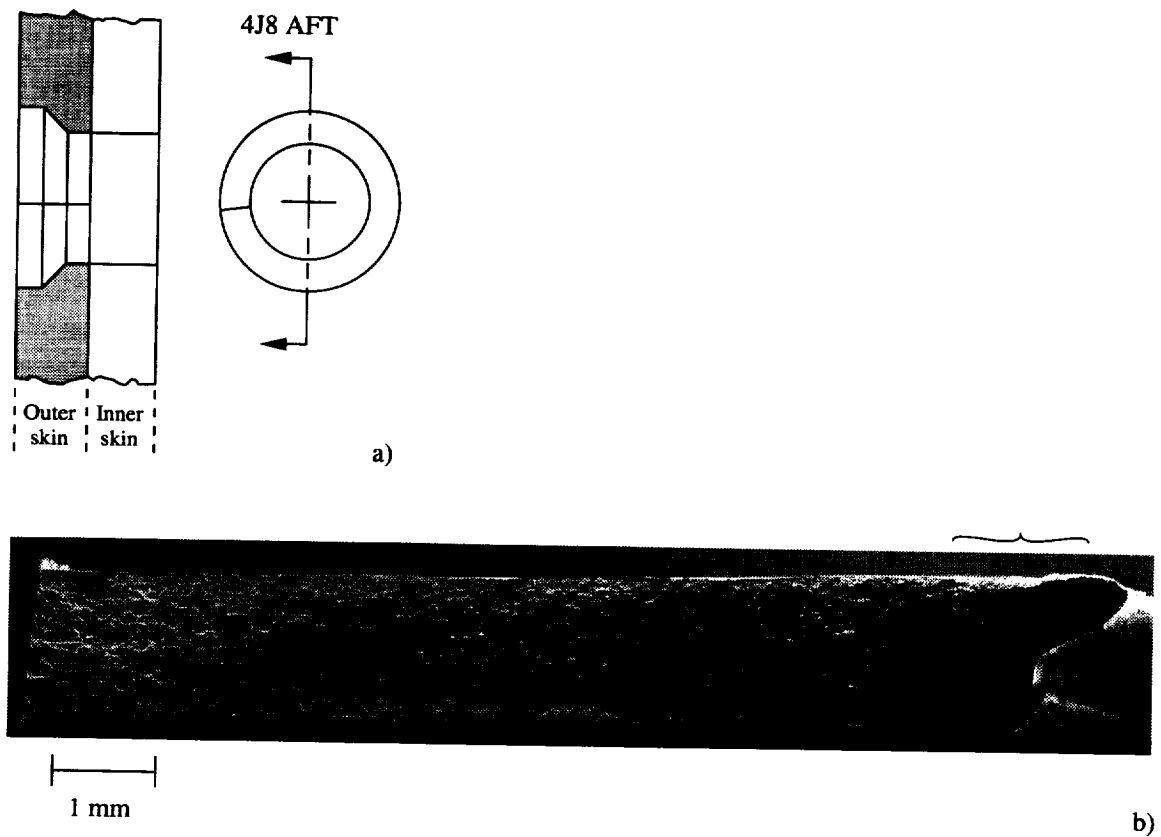
Figure 11.22 a) The schematic shows the rivet hole 4J8 configuration and the location of the outer skin fatigue crack oriented in the aft direction and about the 9 o'clock position. b) The SEM micrograph shows the fatigue crack fracture surface located at the outer skin rivet hole (right). The bracket marks the likely region of crack initiation. The crack front is not visible. This crack linked-up with rivet hole 4J9.

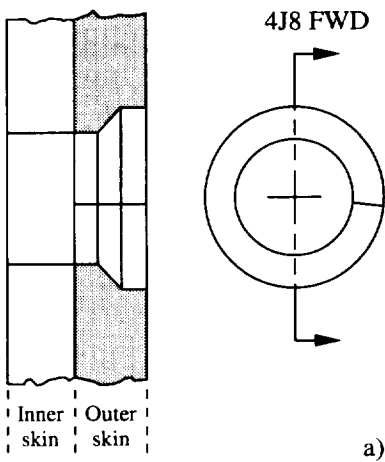
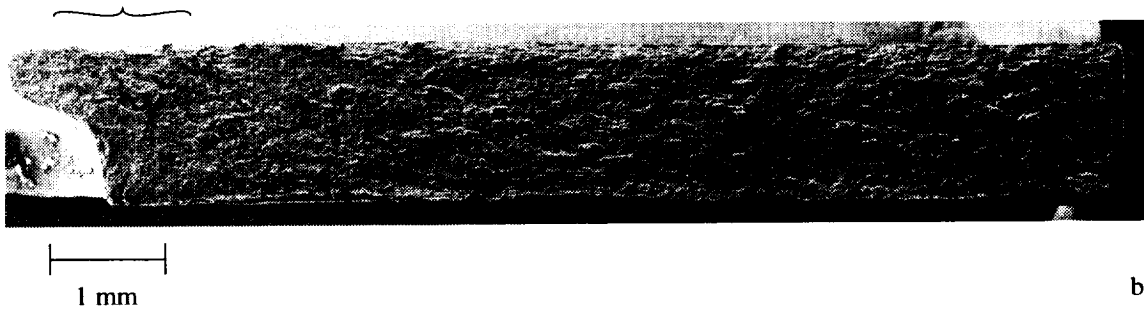
Figure 11.23 a) The schematic shows the rivet hole 4J8 configuration and the location of the outer skin fatigue crack oriented in the forward direction and about the 3 o'clock position. b) The SEM micrograph shows the fatigue crack fracture surface located at the outer skin rivet hole (left). The bracket marks the likely region of crack initiation. The crack front is not visible.

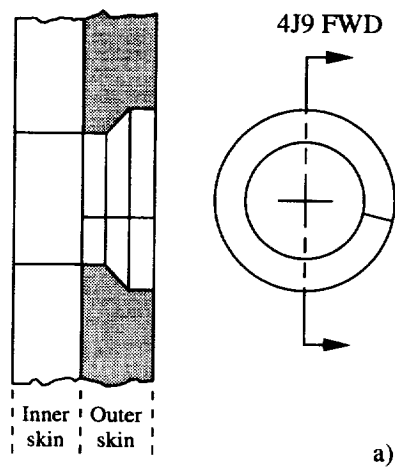
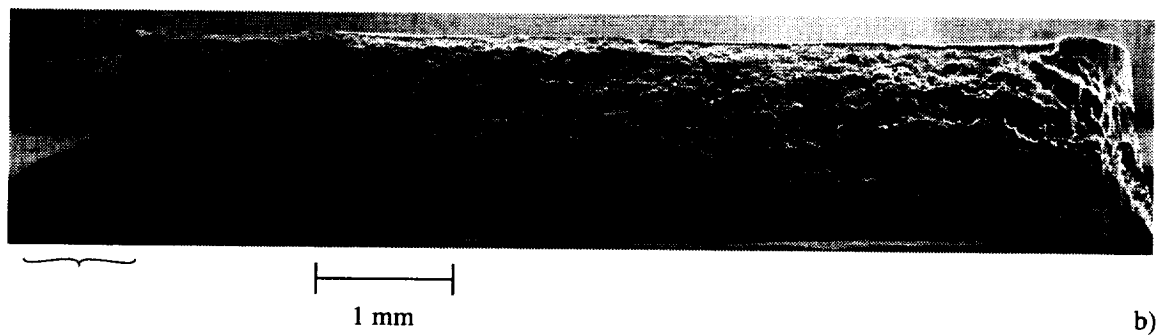
Figure 11.24 a) The schematic shows the rivet hole 4J9 configuration and the location of the outer skin fatigue crack oriented in the forward direction and just below the 3 o'clock position. b) The SEM micrograph shows the fatigue crack fracture surface located at the outer skin rivet hole (left). The bracket marks the likely region of crack initiation. The crack front is not visible.

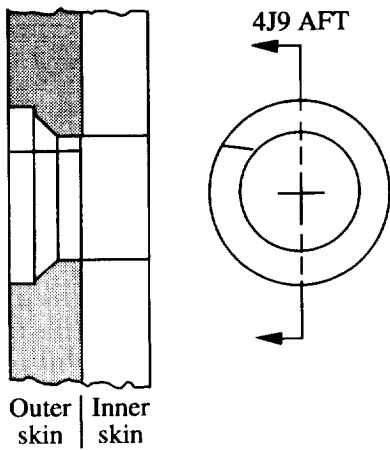
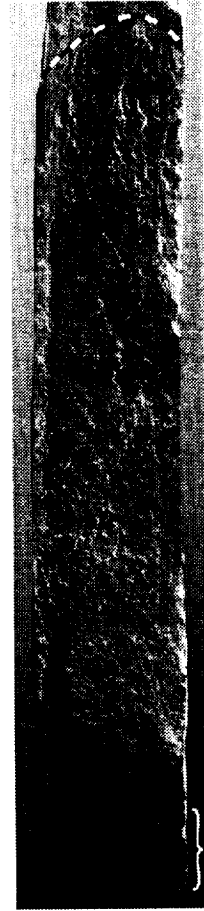
Figure 11.25 a) The schematic shows the rivet hole 4J9 configuration and the location of the outer skin fatigue crack oriented in the aft direction and about the 10 o'clock position. b) The SEM micrograph shows the fatigue crack fracture surface located at the outer skin rivet hole (bottom). The bracket marks the likely region of crack initiation and the dashed line marks the fatigue crack front.

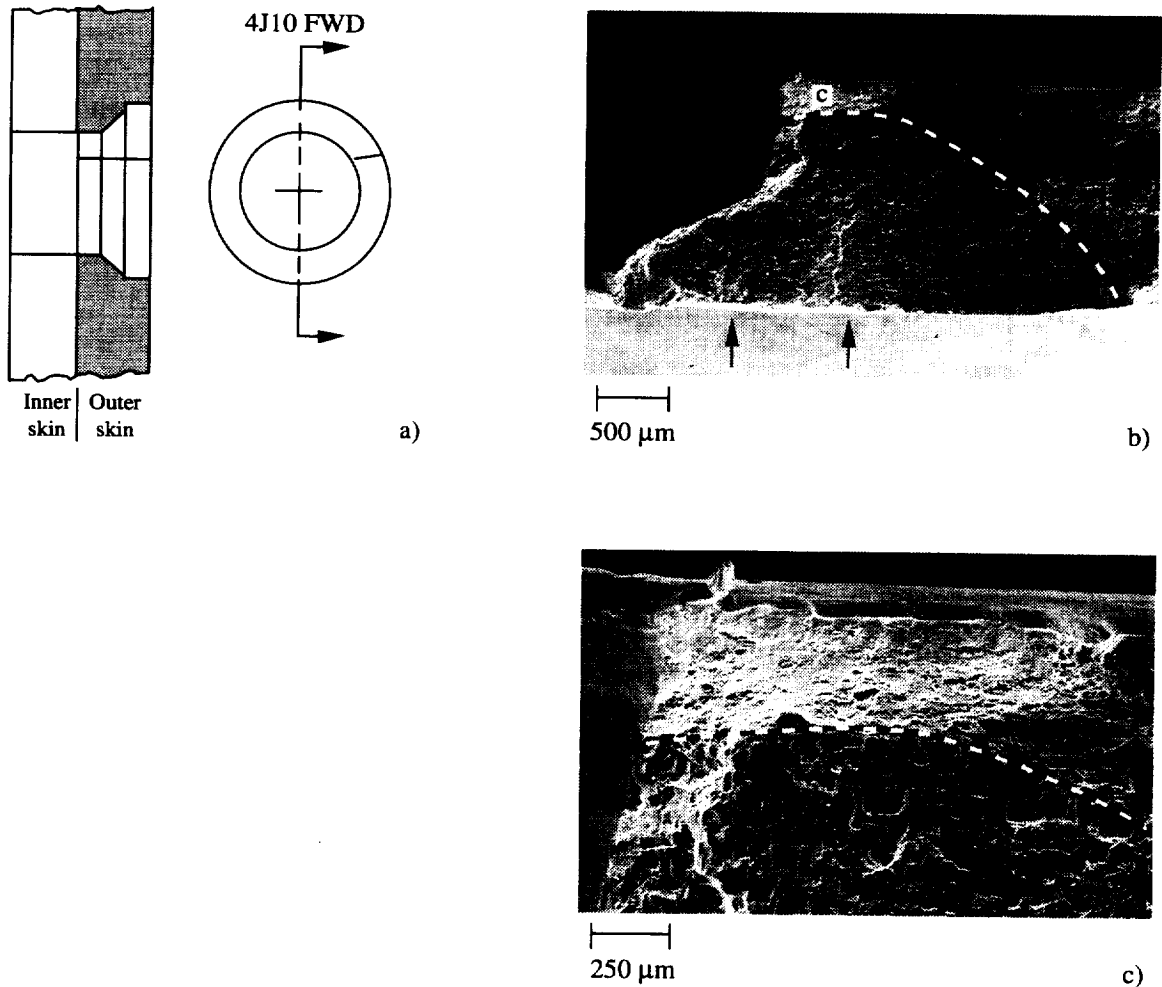
Figure 11.26 a) The schematic shows the rivet hole 4J10 configuration and the location of the outer skin fatigue crack oriented in the forward direction and about the 2 o'clock position. b) The SEM micrograph shows the fatigue crack fracture surface located at the outer skin rivet hole (left). The arrows mark the likely regions of crack initiation and the dashed line marks the fatigue crack front. c) The SEM micrograph shows the fatigue crack front ligament at region "c" in Figure 11.23.b. The dashed line marks the fatigue crack front where it intersects the rivet hole (left). The outboard surface of the outer skin is located at the top of the micrograph.

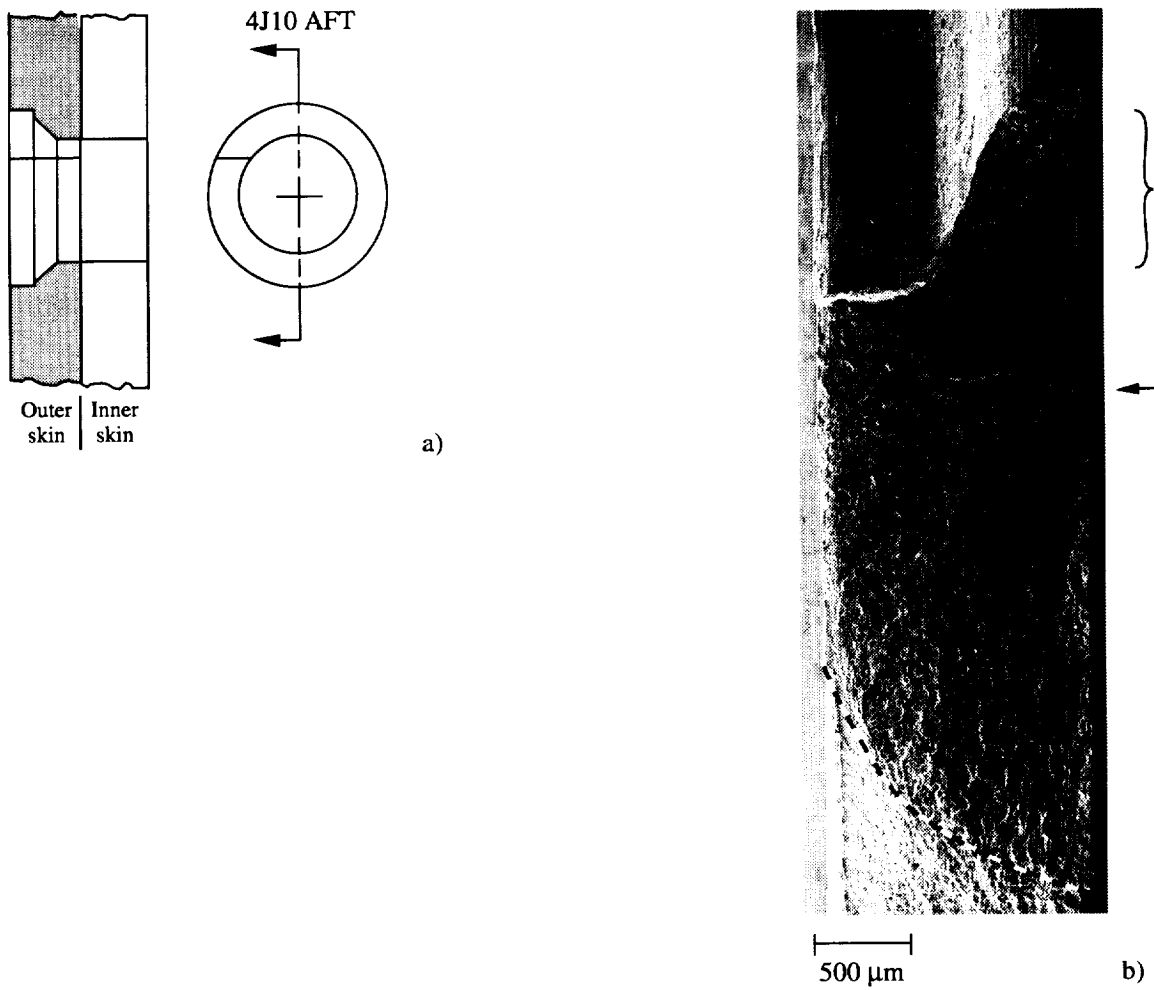
Figure 11.27 a) The schematic shows the rivet hole 4J10 configuration and the location of the outer skin fatigue crack oriented in the aft direction and about the 10 o'clock position. b) The SEM micrograph shows the fatigue crack fracture surface located at the outer skin rivet hole (top). Crack initiation occurred at multiple sites (bracket and arrow) along the faying surface. The dashed line marks the fatigue crack front.

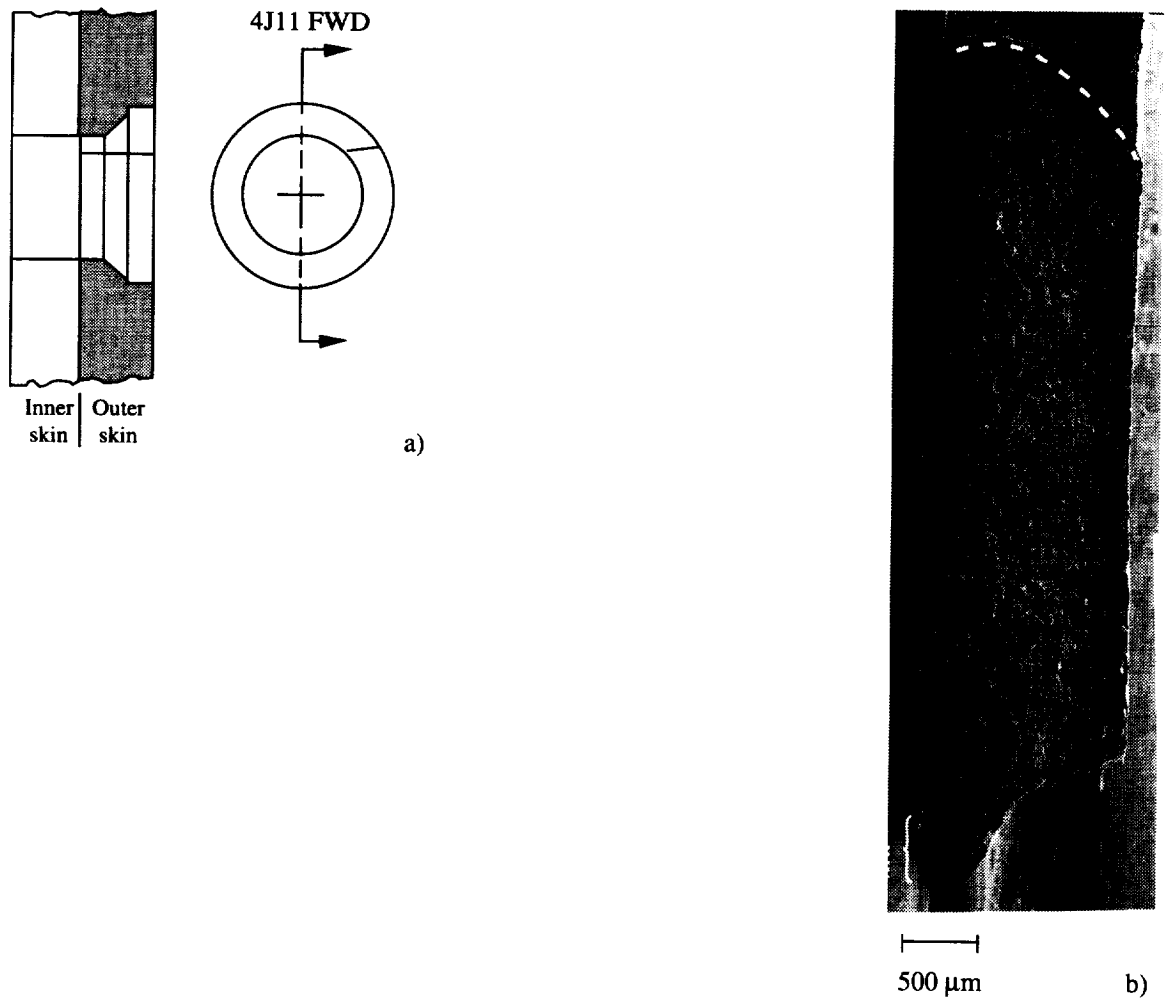
Figure 11.28 a) The schematic shows the rivet hole 4J11 configuration and the location of the outer skin fatigue crack oriented in the forward direction and about the 2 o'clock position. b) The SEM micrograph shows the fatigue crack fracture surface located at the outer skin rivet hole (bottom). The bracket shows the likely region of crack initiation and the dashed line marks the fatigue crack front.

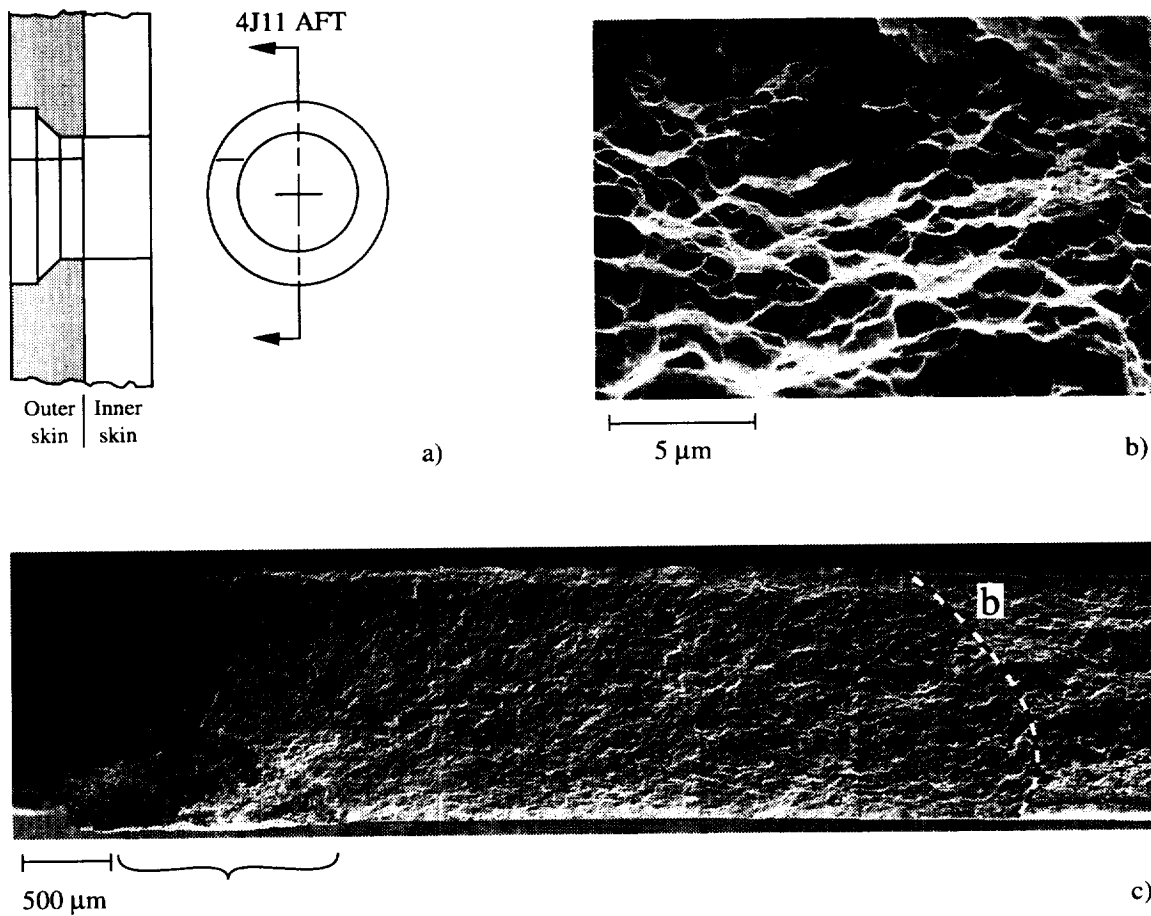
Figure 11.29 a) The schematic shows the rivet hole 4J11 configuration and the location of the outer skin fatigue crack oriented in the aft direction and about the 10 o'clock position. b) The SEM micrograph shows the ductile tearing morphology of the overload fracture surface at region "b" in Figure 11.26.c. c) The SEM micrograph shows the fatigue crack fracture surface located at the outer skin rivet hole (left). The bracket shows the region of crack initiation along the faying surface and the dashed line marks the fatigue crack front.

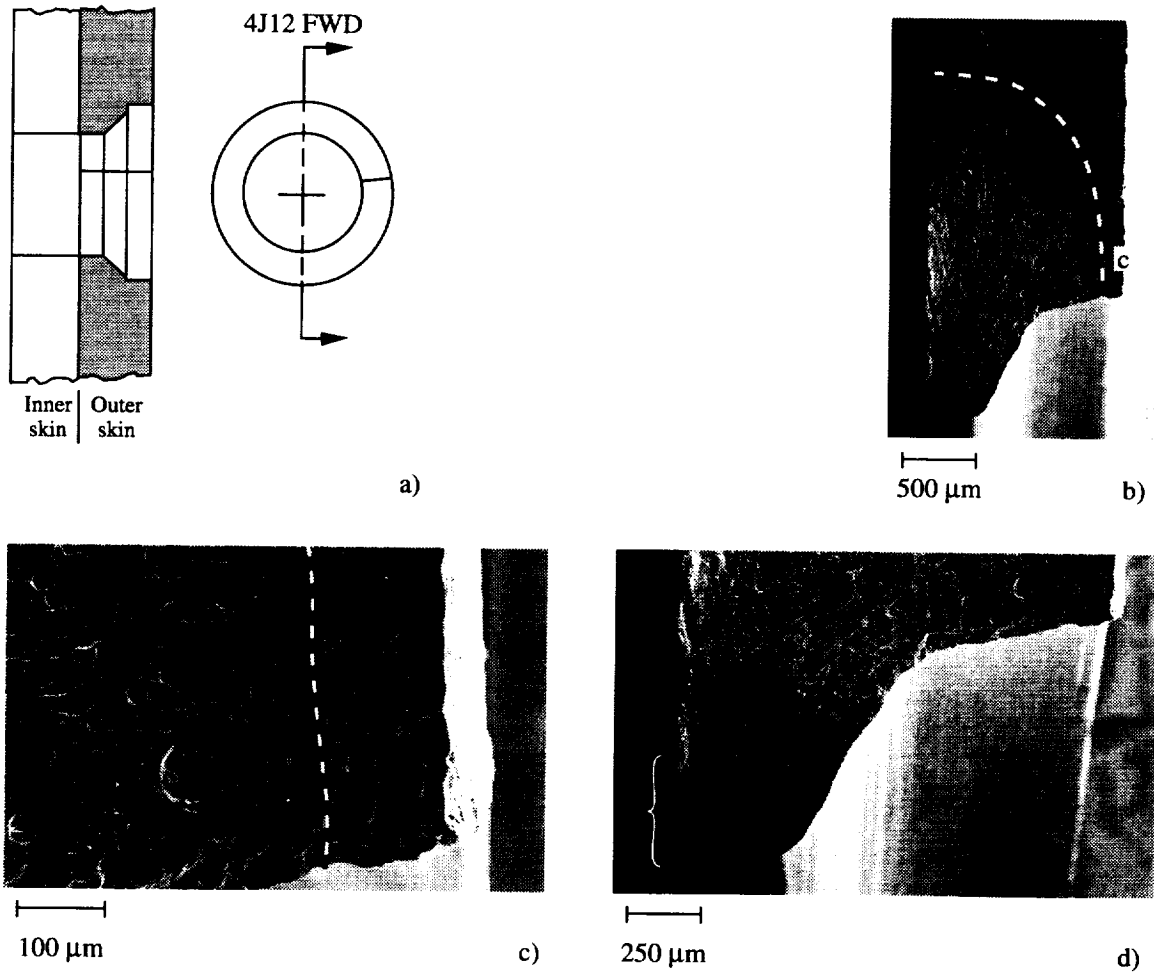
Figure 11.30 a) The schematic shows the rivet hole 4J12 configuration and the location of the outer skin fatigue crack oriented in the forward direction and above the 3 o'clock position. b) The SEM micrograph shows the fatigue crack fracture surface located at the outer skin rivet hole (bottom). The dashed line marks the fatigue crack front. c) The SEM micrograph shows the fatigue crack front at region "c" in Figure 11.27.b. The dashed line marks the fatigue crack front where it intersects the rivet hole (bottom). The outboard surface of the outer skin is located at the right of the micrograph. d) The SEM micrograph shows the fatigue crack initiation region located at the faying surface (bracket).

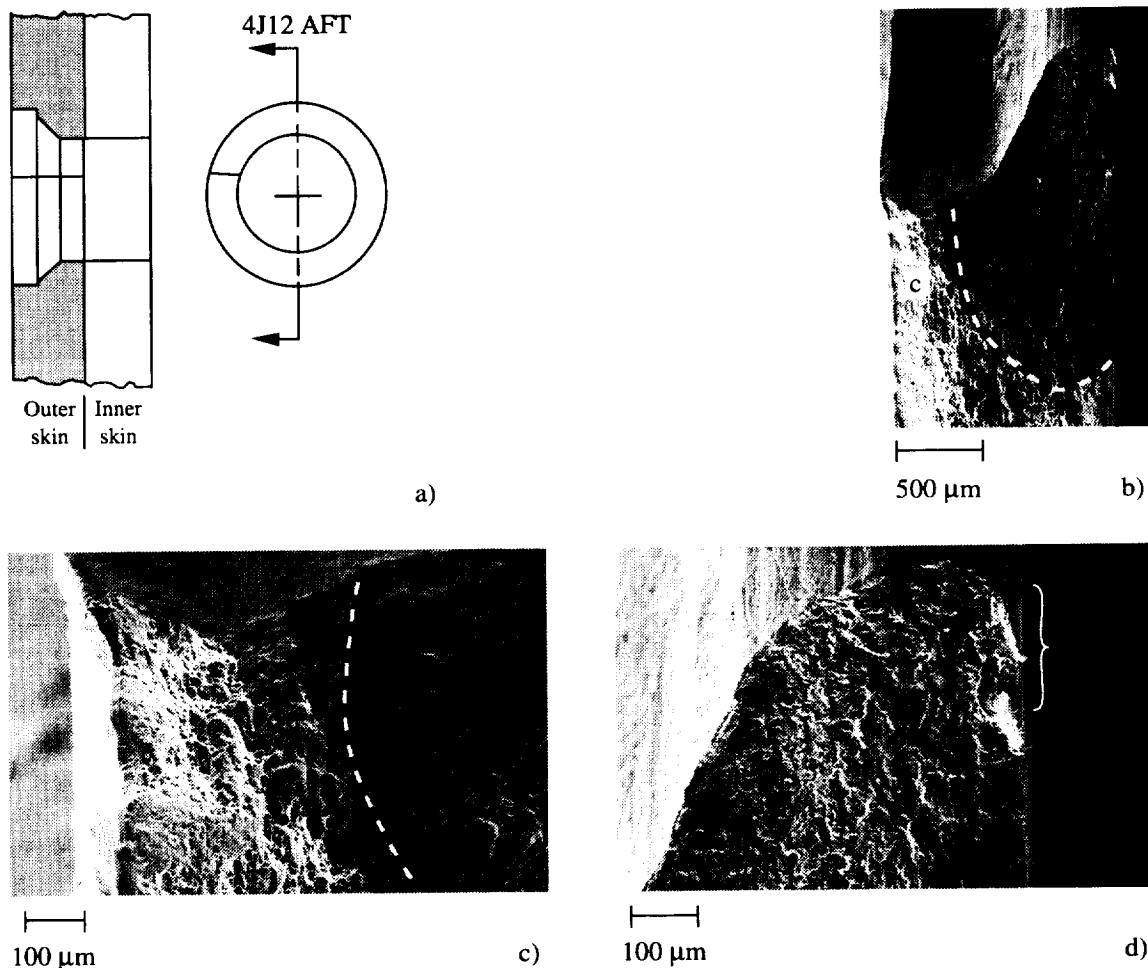
Figure 11.31 a) The schematic shows the rivet hole 4J12 configuration and the location of the outer skin fatigue crack oriented in the aft direction and above the 9 o'clock position. b) The SEM micrograph shows the fatigue crack fracture surface located at the outer skin rivet hole (top). The dashed line marks the fatigue crack front. c) The SEM micrograph shows the fatigue crack front at region "c" in Figure 11.28.b. The dashed line marks the fatigue crack front where it intersects the rivet hole (bottom). The outboard side of the outer skin is located at the left of the micrograph. d) The SEM micrograph shows the fatigue crack initiation region located along the faying surface (bracket).

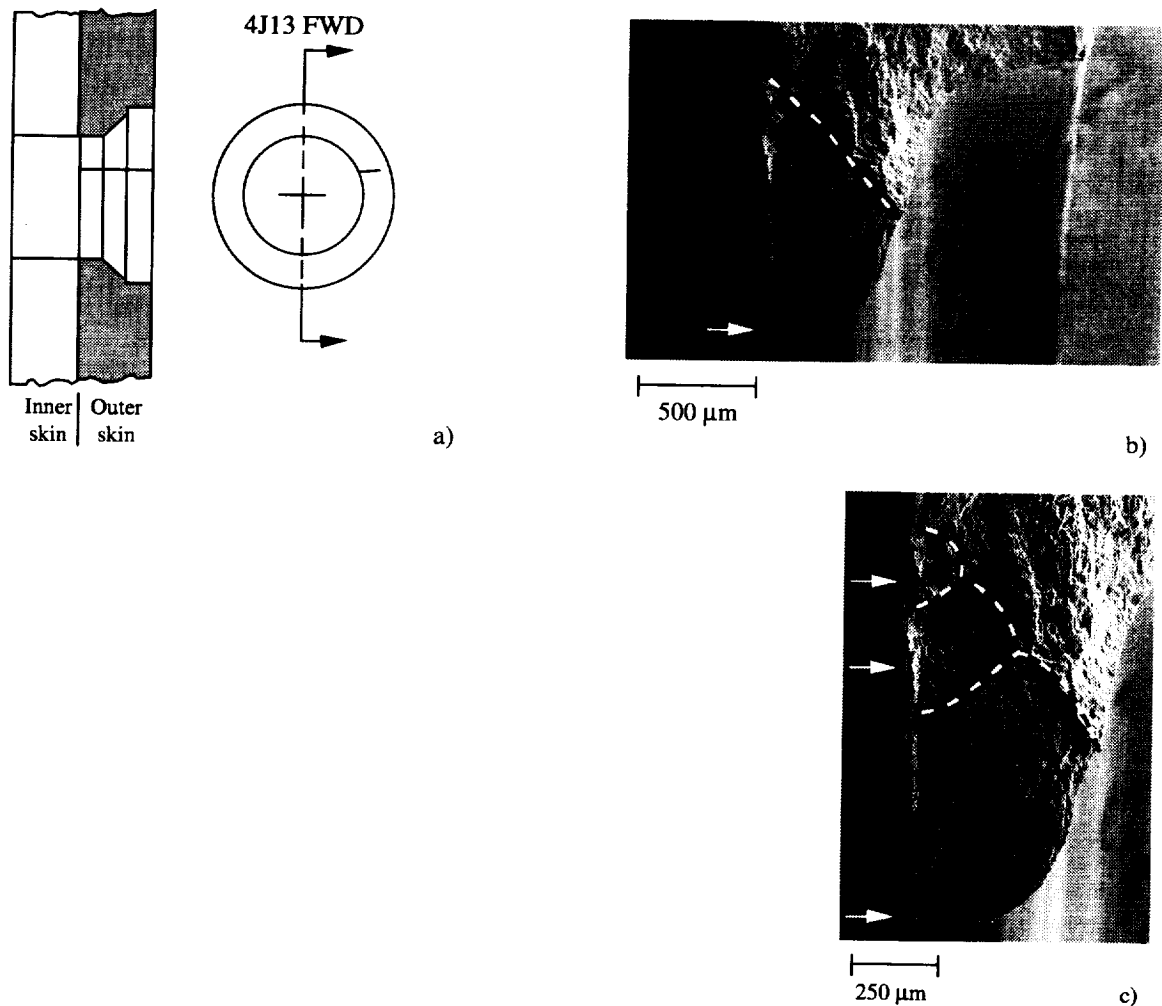
Figure 11.32 a) The schematic shows the rivet hole 4J13 configuration and the location of the outer skin fatigue crack oriented in the forward direction and below the 2 o'clock position. b) The SEM micrograph shows the fatigue crack fracture surface located at the outer skin rivet hole (bottom). The dashed line marks the fatigue crack front. c) The SEM micrograph shows the fatigue crack initiation region located along the faying surface (arrows). The dashed lines mark the crack front.

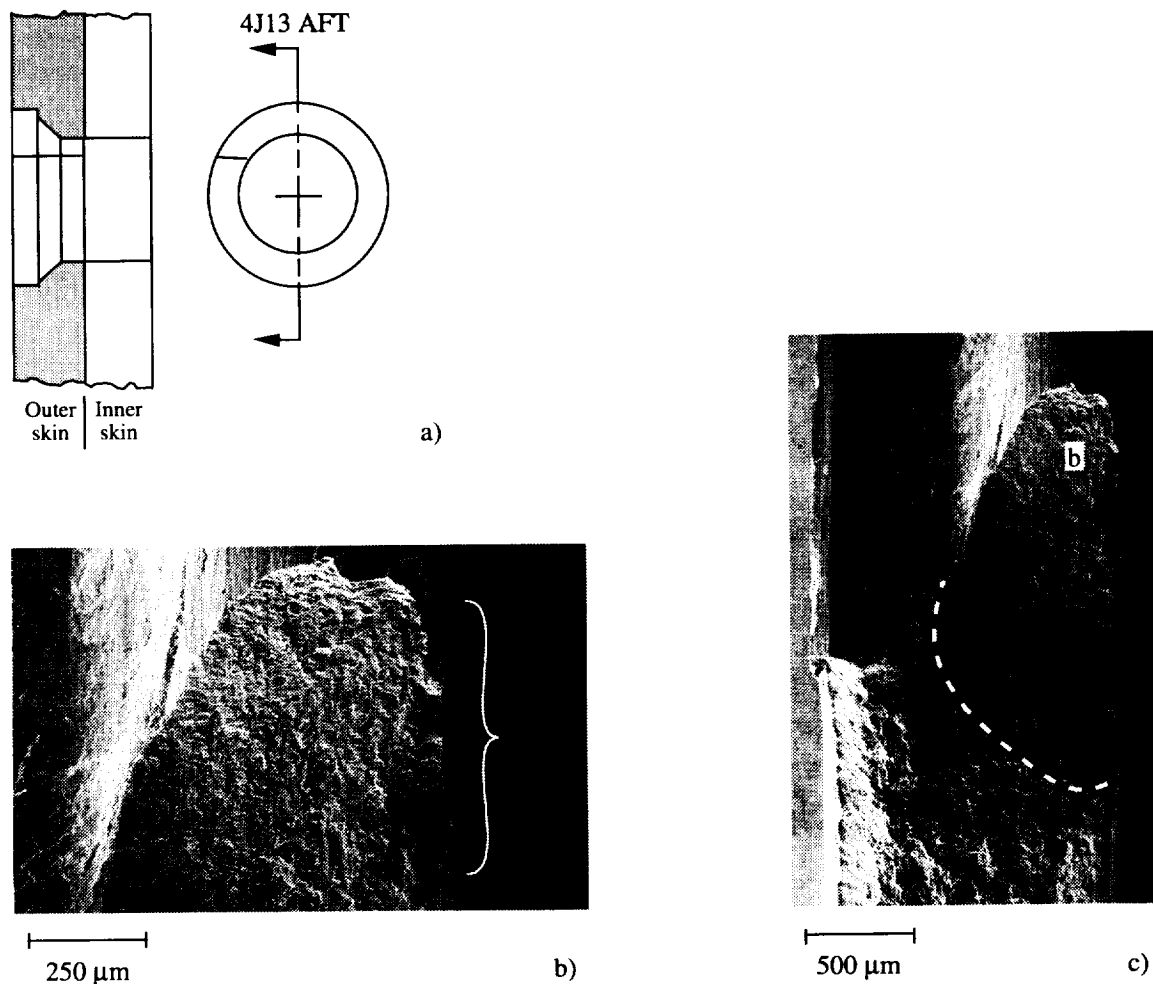
Figure 11.33 a) The schematic shows the rivet hole 4J13 configuration and the location of the outer skin fatigue crack oriented in the aft direction and about the 10 o'clock position. b) The SEM micrograph shows the rivet hole shank region and the likely fatigue crack initiation region located at the inboard corner of the rivet hole (bracket). c) The SEM micrograph shows the fatigue crack fracture surface located at the outer skin rivet hole (top). The dashed line marks the fatigue crack front.
